St.Amant implements a Mattress Inspection and Repair program with CleanPatch® to extend the life of its bath stretcher mattresses while reducing the risk of *Clostridium difficile* (*C. difficile*) infections

A Case Study – June 2016

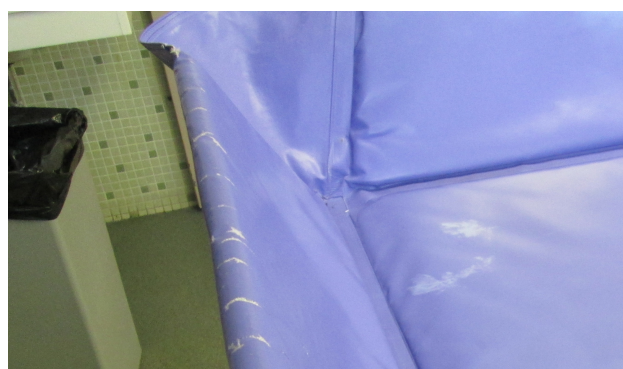
Figure 1. Damaged areas on shower stretcher

Following the inspection of all bath stretcher mattresses, it was found that damage typically occurs along the side edges of the mattress. So, in addition to addressing existing damage with CleanPatch, St.Amant also uses CleanPatch as a preventive maintenance tool by applying CleanPatch to the high wear areas of new bath stretcher mattresses.

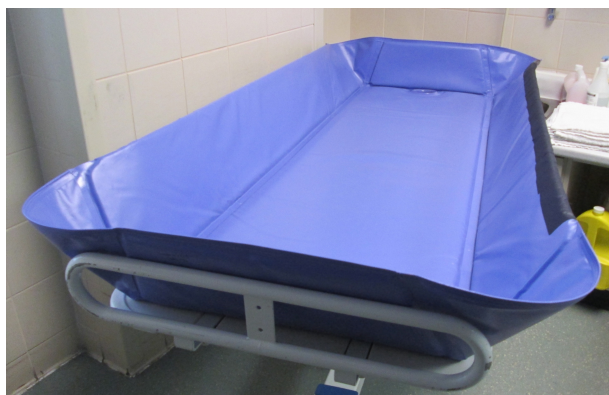
Figure 2. Preventative application of CleanPatch to high wear area (9 months after application)
